# The Benefits And Limitations Of Corrosion Coupons

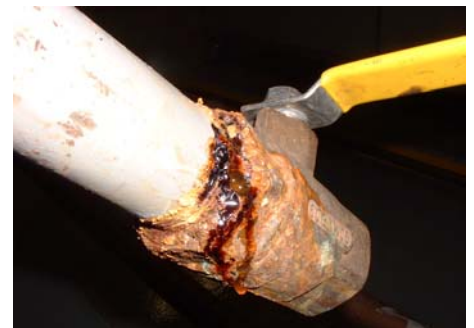
Since corrosion coupons are typically isolated from any metal to metal contact through the use of a center located plastic or galvanic insulator, they are totally unaffected by the many anode/cathode electrochemical reactions always present in an established piping system.

The well recognized steel pipe to brass valve or copper pipe effect is a common example of galvanic forces which always exist to some degree in most piping systems. Lesser galvanic forces exist where different steels meet as well.

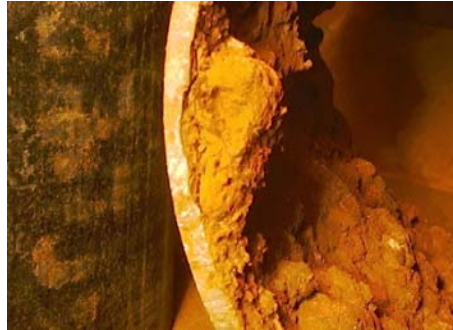
Heavy deposit buildup, however, will likely isolate the pipe from any chemical protection whatsoever. This often results in random areas of pipe having deep wall loss - often at the lowest areas of the system and at long horizontal runs. Smallest diameter piping is especially vulnerable.

A 5 MPY corrosion rate against 12 in. schedule 40 steel pipe, for example, will actually remove 64 lbs. of metal into the circulating system for every 100 linear feet of pipe, and for every year of service!
